**Flight Service Evaluation of
Kevlar-49 Epoxy Composite Panels
in Wide-bodied Commercial
Transport Aircraft**

Eighth Annual Flight Service Report

R.H. Stone

LOCKHEED-CALIFORNIA COMPANY
BURBANK, CALIFORNIA

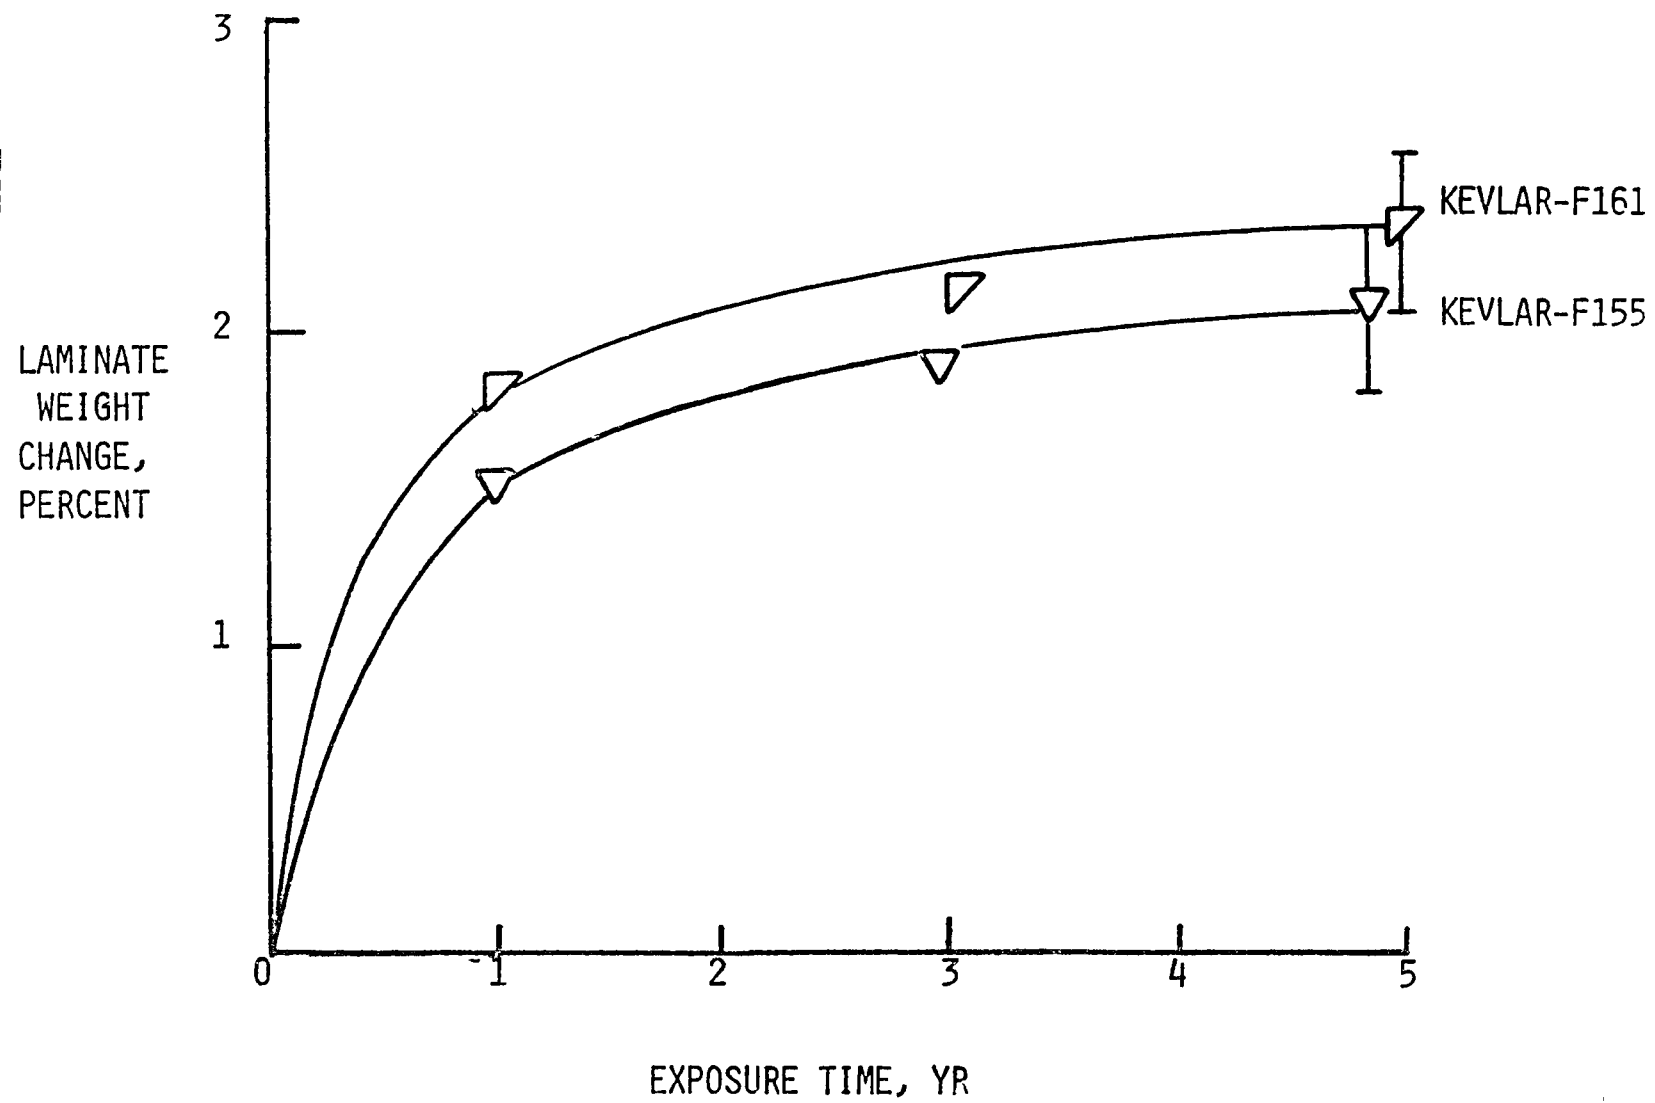
Figure 6. - Moisture Pickup for Flexure Specimens After Worldwide Exposure.

The moisture pickup over a 5 year period is shown in Figure 6. On a world-wide basis, both systems appear to be stabilizing slightly above 2 percent moisture pickup. Since 7 year specimens have not fully dried, these data are not yet available.

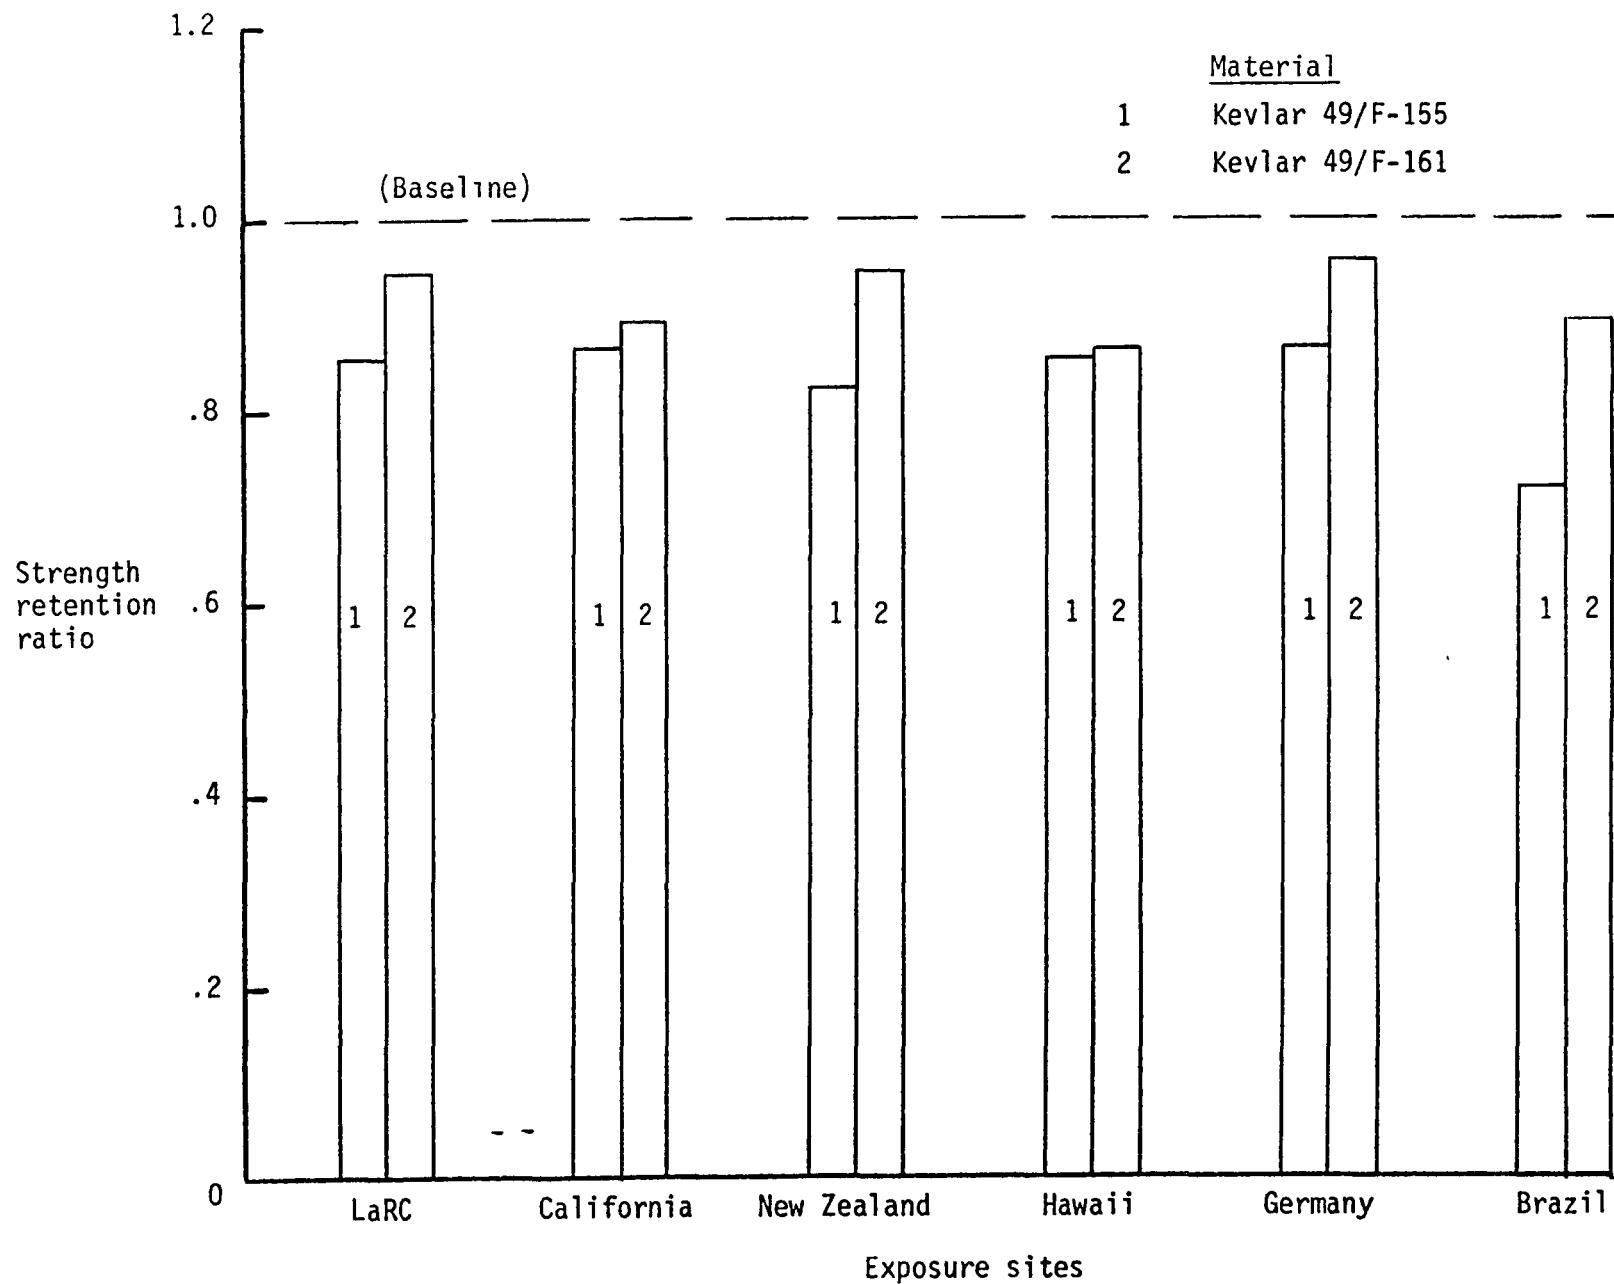
Figure 7. - RT Shear Strength Retention of Kevlar/Epoxy After 5 Years Outdoor Ground-Based Exposure.

Tables 2, 3 and 4 show the shear, compression and flexure strengths, respectively, for all the 5 and 7 year specimens. The average baseline strength value is also shown for each material system. Figures 7 through 12 show 5 and 7 year strength ratios for both material systems. The strength ratio is a comparison of the average specimen strength with the average baseline strength for the material system. There is some degradation in shear strength for both systems over the 7-year period. However, both Aloha and Lufthansa specimens show shear strength ratio values about 13 percent above the baseline value for Kevlar 49/F-161. The greatest strength reduction (28 percent) is for the Kevlar/F-155 specimens exposed in Brazil for 7 years. Compression strength ratio values have also degraded somewhat after 7 years exposure with a maximum 18-20 percent strength reduction in 7-year VASP specimens. Flexure strength ratio values are relatively stable throughout the 7-year period with values for the Kevlar 49/F-155 system generally lower than those for the Kevlar 49/F-161 system. The maximum flexure strength reduction (16 percent) is for Kevlar 49/F-155 specimens exposed in California for 7 years.
